**US Army Corps
of Engineers**

USACERL Technical Report 96/77
July 1996

Investigation of Preapproved Underground Heat Distribution Systems

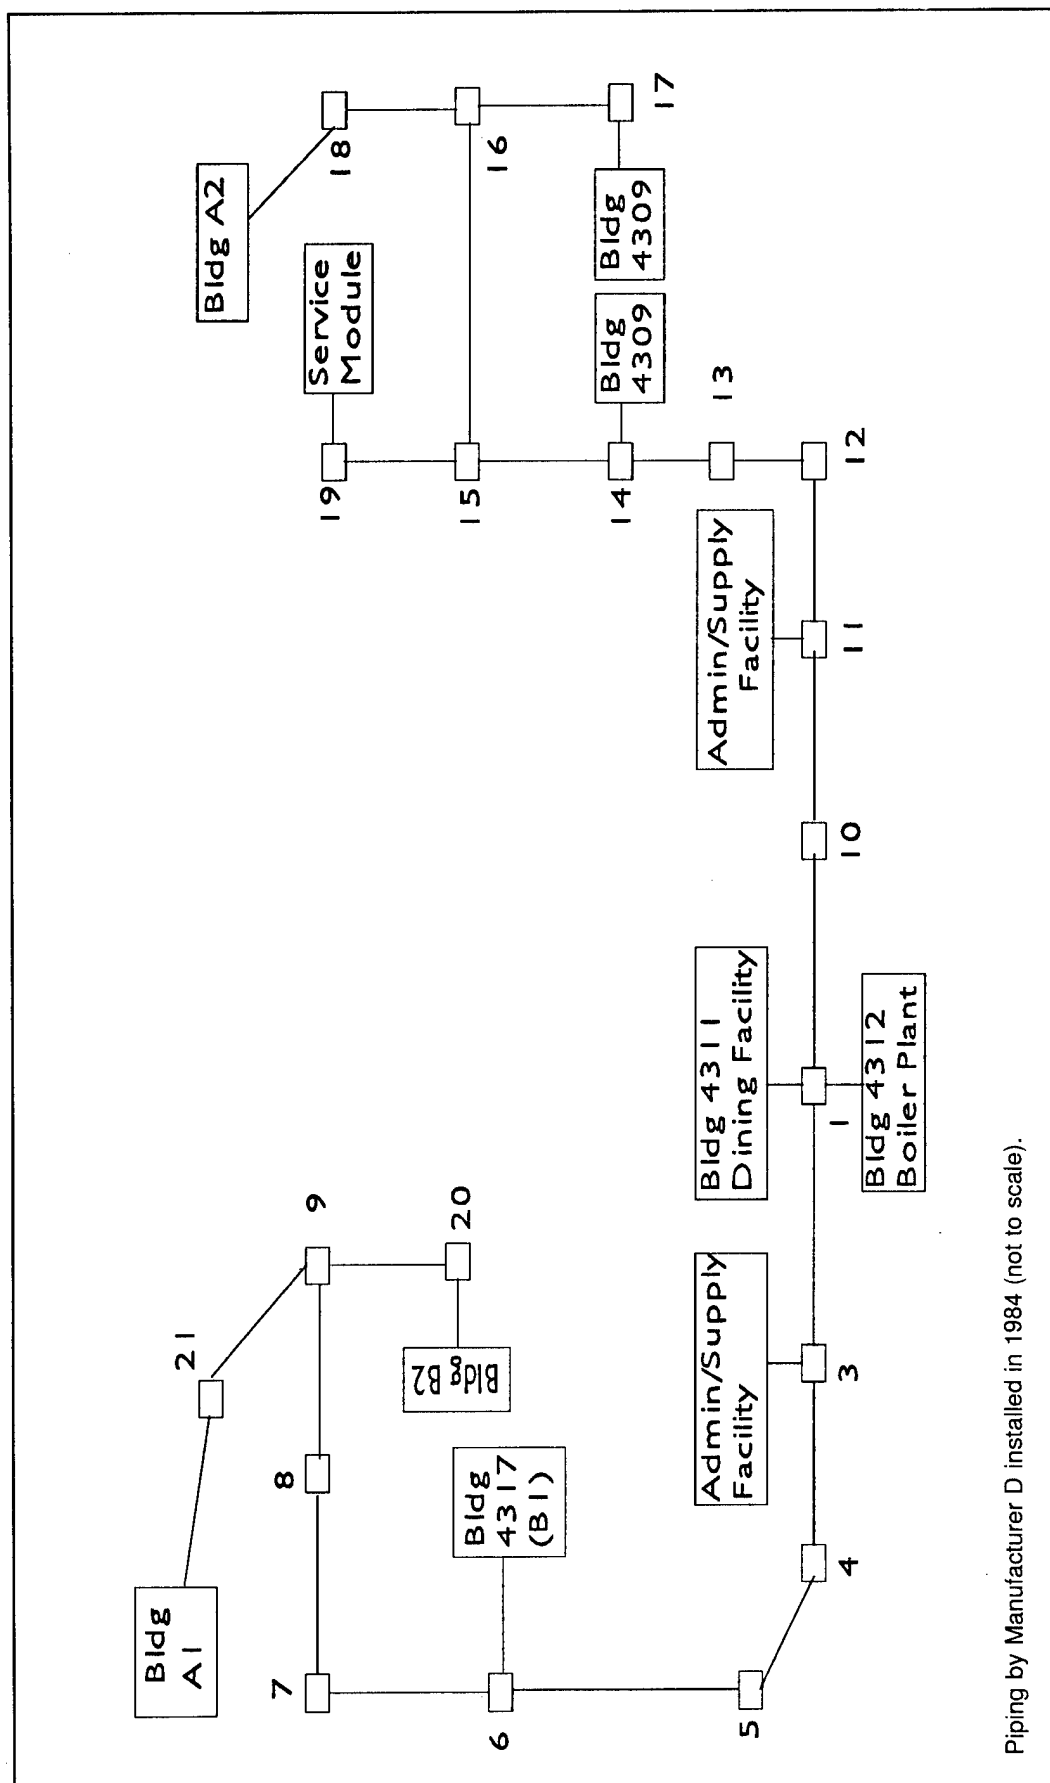
Figure C1. Schematic drawing of System 1 at Aberdeen Proving Grounds, MD.

f. Manhole 6—This manhole serves Building 4317. The sump pump was operational, and the manhole was dry. No steaming was observed at conduit vents. In this manhole, the steam supply and condensate return lines transition from

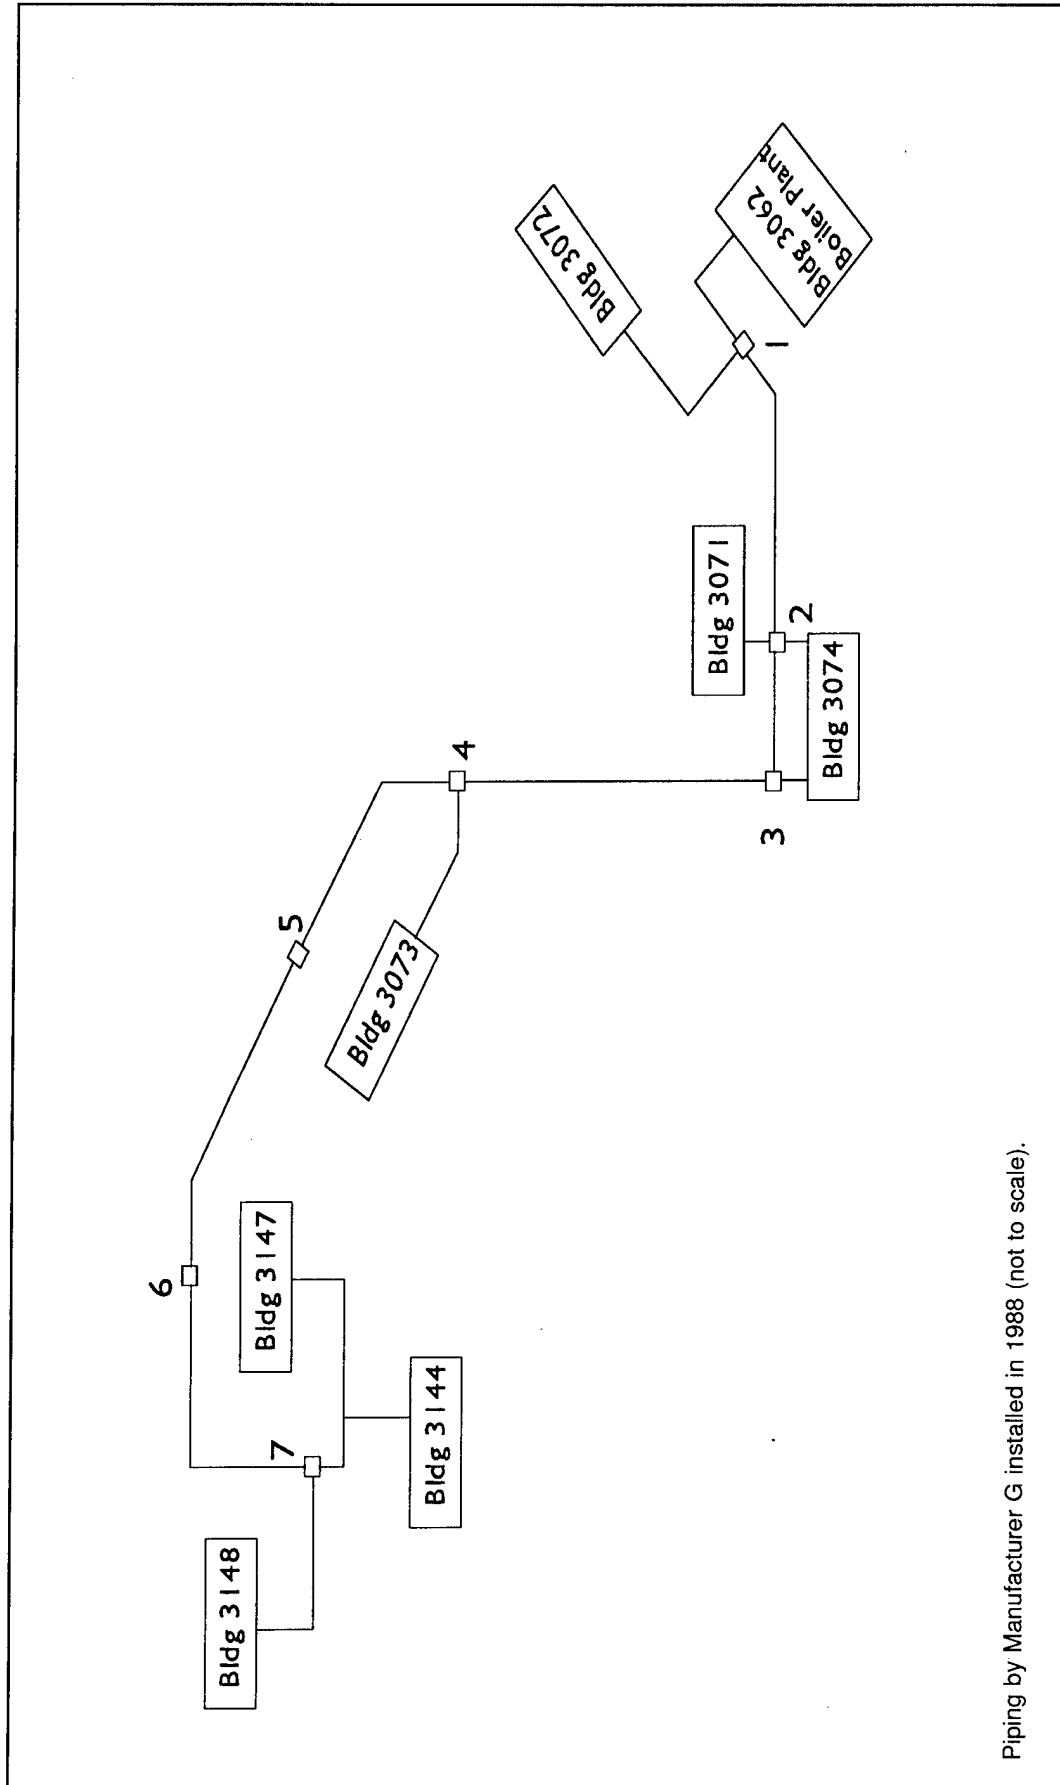
Figure C2. Schematic drawing of System 2 at Aberdeen Proving Grounds, MD.

This system consists of piping from Manufacturer G and has an FRP conduit (Figure C2). The project was "Replace Underground Steam and Condensate Piping From Boiler Plant (Bldg. 3062) to Bldgs. 3071, 3072, 3073, 3074, 3144, 3147 & 3148" (Drawing No. A38972) and was dated 1988.

a. Boiler Plant (Building 3062)—This boiler plant contains two oil-fired boilers, each rated at 12,552,000 Btu/hr. The operating steam pressure was 15 psi. No vents were installed on the conduits leaving the building.

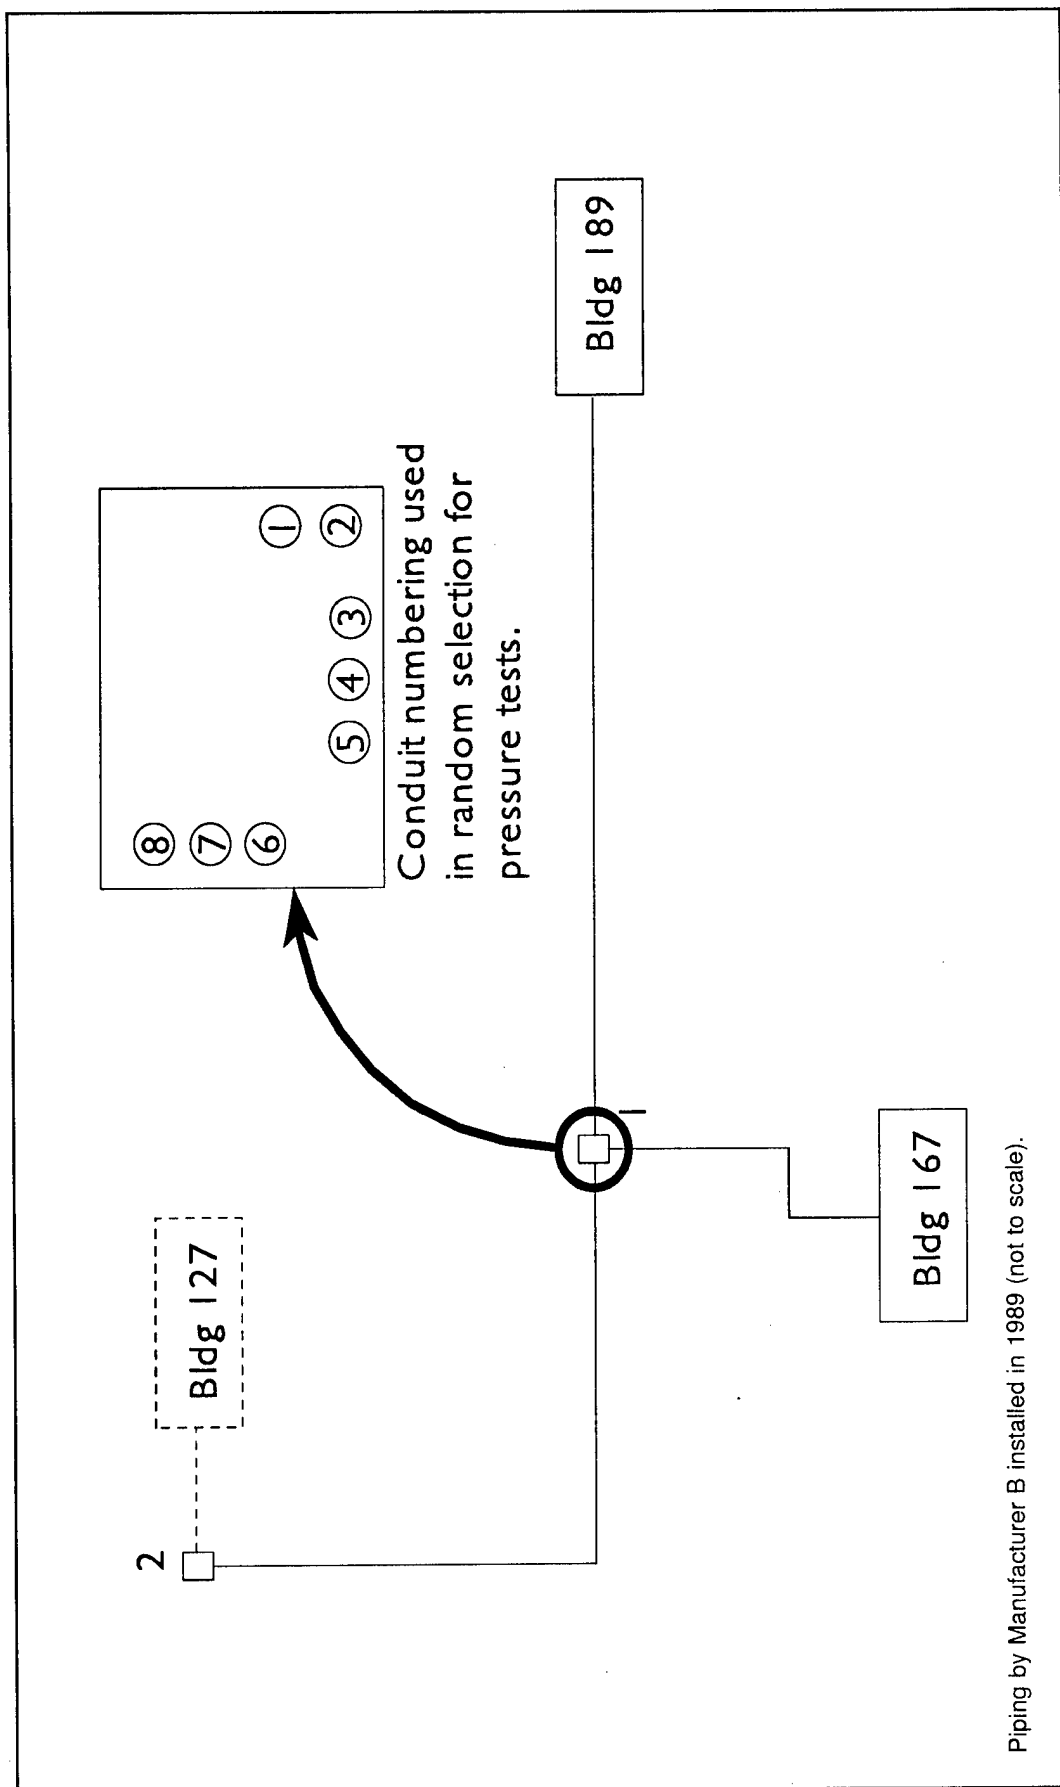
Figure D1. Schematic diagram of System 3 at Wright-Patterson AFB, OH.

a. Equipment Room - Building 189—Steam and condensate lines were contained in individual conduits. The steam conduit casing did not extend through the wall into

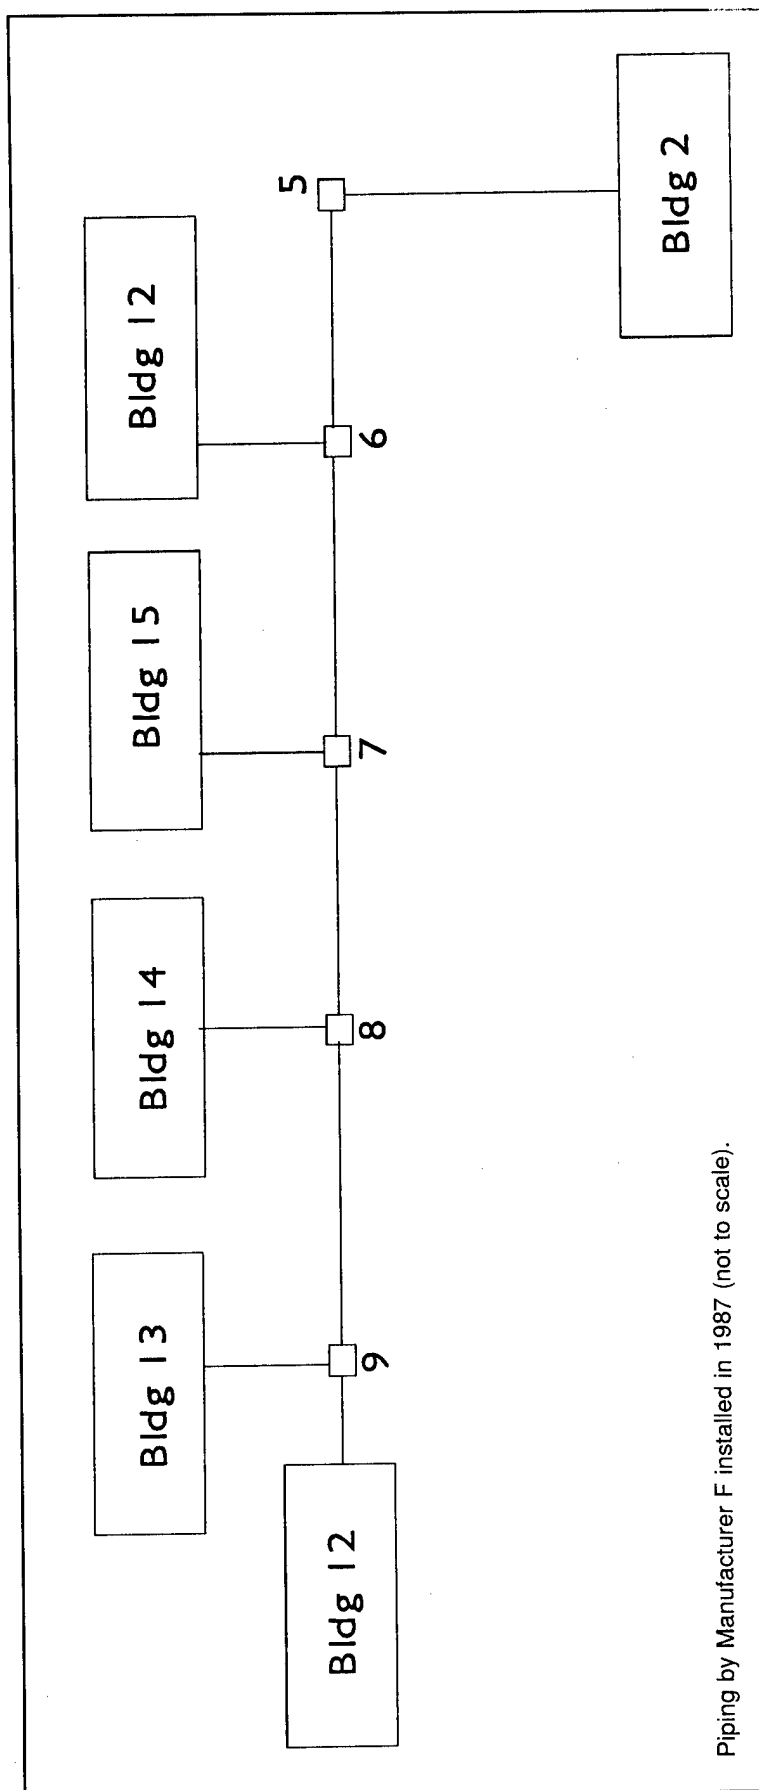
a. Manhole 5—This manhole was round with a 6-ft diameter, was 9-ft deep, and was a solid concrete top design with a 30-in. manhole cover. No sump pump or means for ventilation were provided, and the manhole contained 3 in. of standing water. A

water line on the manhole wall indicated previous flooding above the piping. Both vent and drain openings were plugged. A submerged trap assembly produced some steaming. The bottom ladder rung was about 3 ft above the manhole floor. The wall penetrations were caulked. Where the FRP casing was bonded to the end plate assembly, the color had changed to a dark orange or tan. The steam conduit temperature was 185 °F.

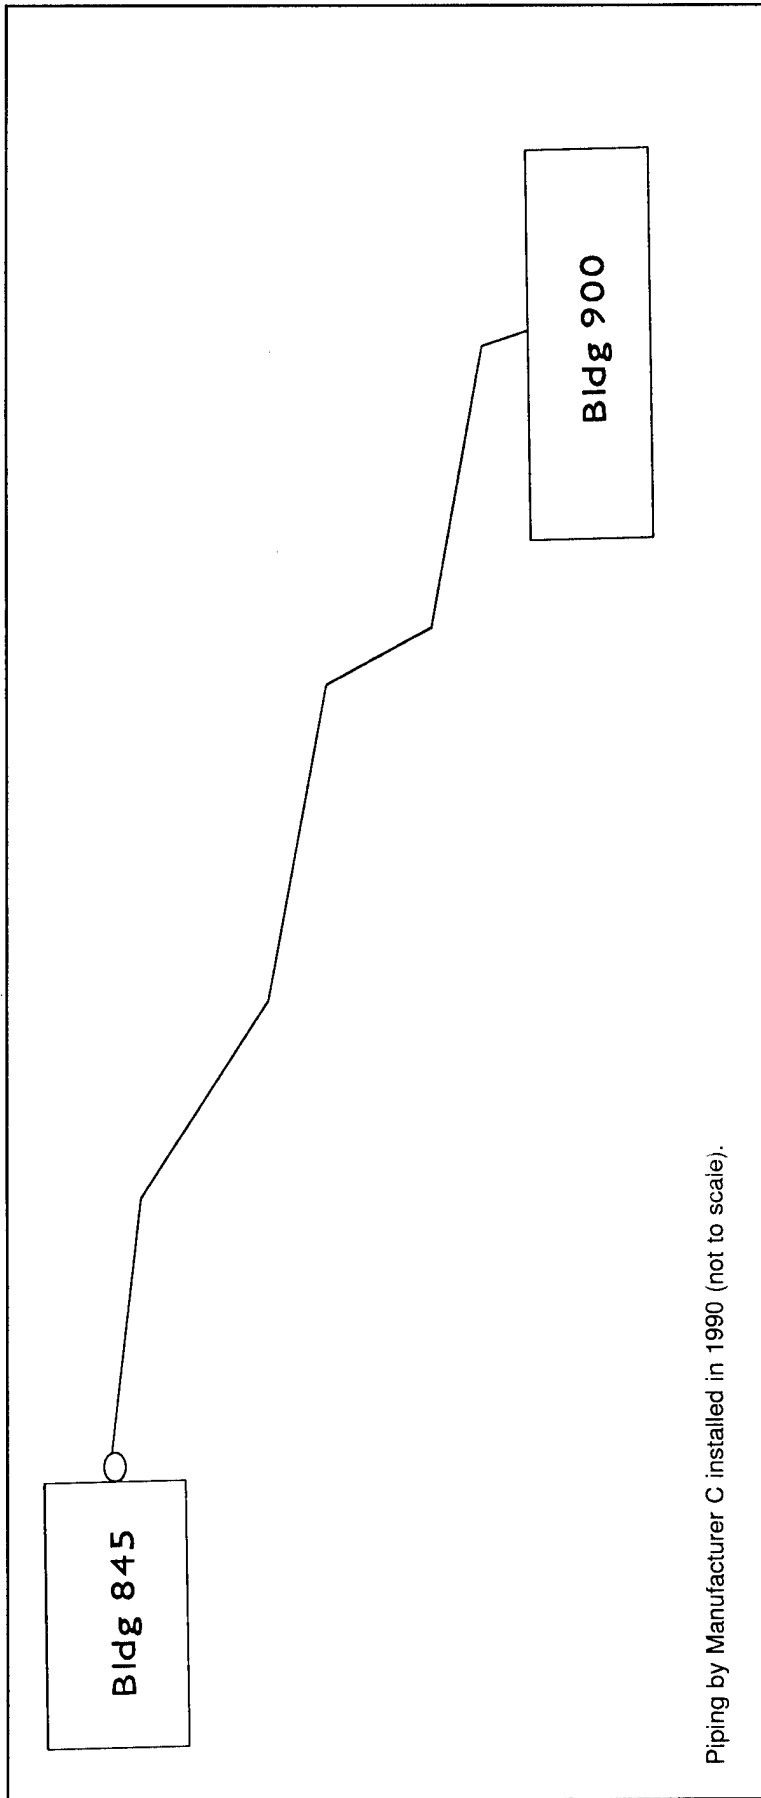
Figure F2. Schematic diagram of System 11 at USMA, West Point, NY.

c. Cathodic Protection—The steel conduit had an installed cathodic protection system consisting of buried zinc anodes. The isolating flange assembly was found to lack the necessary dielectric washers and bolt sleeves needed to achieve electrical isolation. A test station was located about 10 ft from the riser at Building 845. The pipe potential was found to be -0.66V, which was insufficient and above the standard of -0.85V. An anode potential reading of 1.86V indicated plenty of remaining anode life.

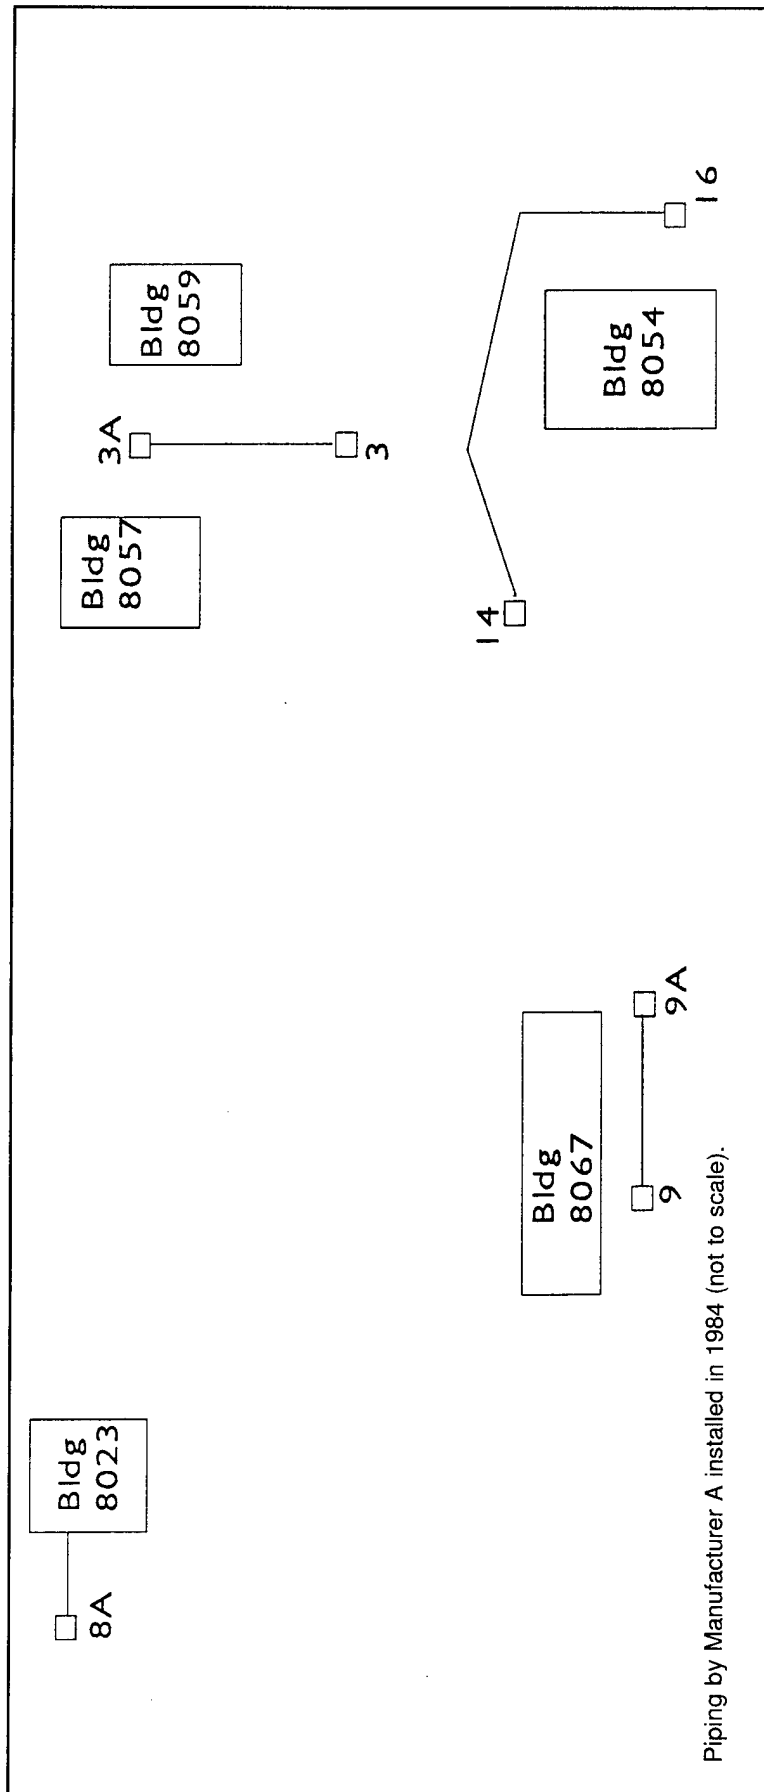
Figure G1. Schematic diagram of System 12 at Fort Riley, KS.

a. Manhole 3—This manhole was 6 ft x 6 ft x 13 ft deep and was a raised top design with steel plate covers. The transition from a shallow trench system in one wall was made to buried conduits to the other three walls. Each conduit contains both steam and condensate piping. The end plate of the conduit from Manhole 4 was recessed into the manhole wall. All end plates showed minor general corrosion. The manhole was dry, and the sump pump was functioning properly. No evidence of water or steam in the conduits was found.

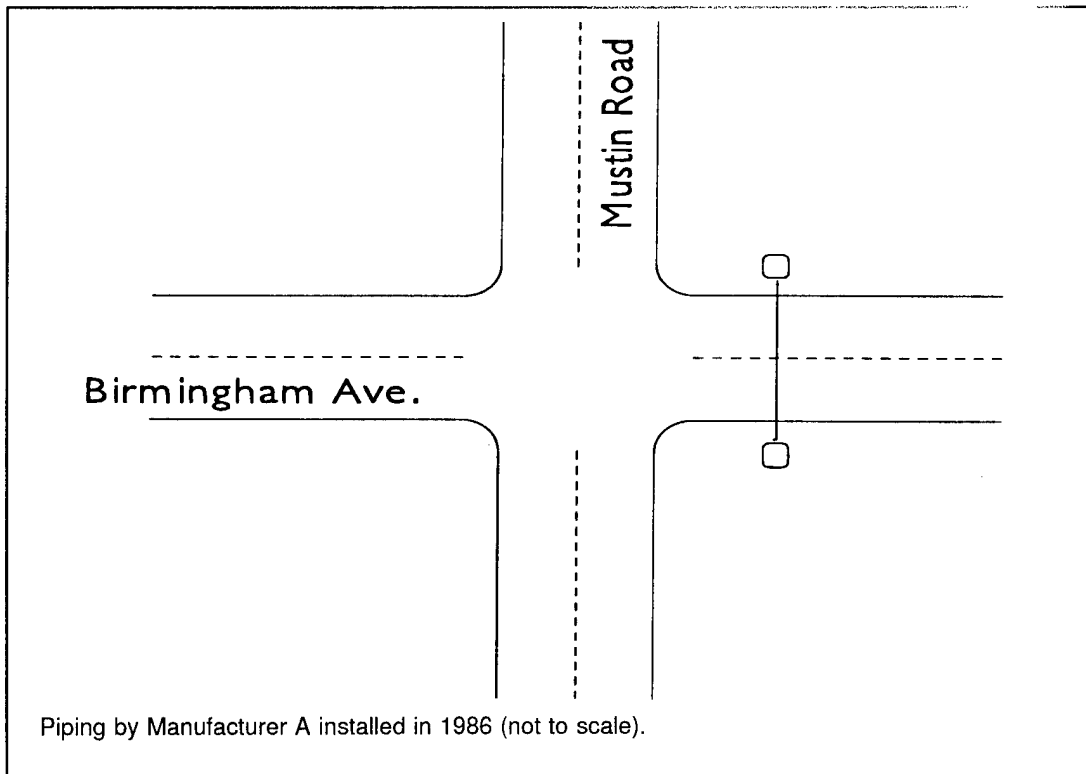
Figure I2. Schematic diagram of System 15 at Jacksonville NAS, FL.

This system consists of a single road crossing with piping from Manufacturer A and has a steel conduit (Figure I2). Installed in 1986, the project is under Birmingham Avenue near the intersection with Mustin Street. Risers on both sides of the street are fitted with loose water shed caps that precluded pressure testing.

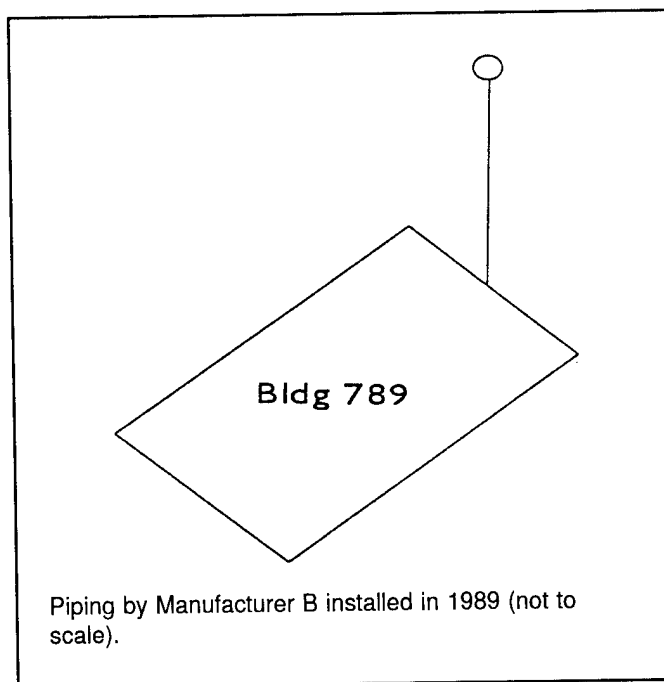
Figure I6. Schematic diagram of System 19 at Jacksonville NAS, FL.

This system consists of piping from Manufacturer B and has a steel conduit (Figure I6). It consists of a transition from above ground to below ground without a manhole. A single conduit containing both steam and condensate piping crosses Birmingham street and feeds Building 789. The riser had a loose water shed cap and the "Fostercoat" coating had some minor deterioration. The equipment room pit is 4 ft x 4 ft x 12 ft deep and has an electric sump pump. Gland seals were used at the end plates for both the steam and condensate piping. The single conduit drain was

plugged, but the vent was recessed into the pit wall and was full of concrete. The wall penetration was cemented and caulked, but slight water infiltration was noted. Some water seepage was also evident at an old wall penetration. A pressure test could not be performed because of the rain cap.

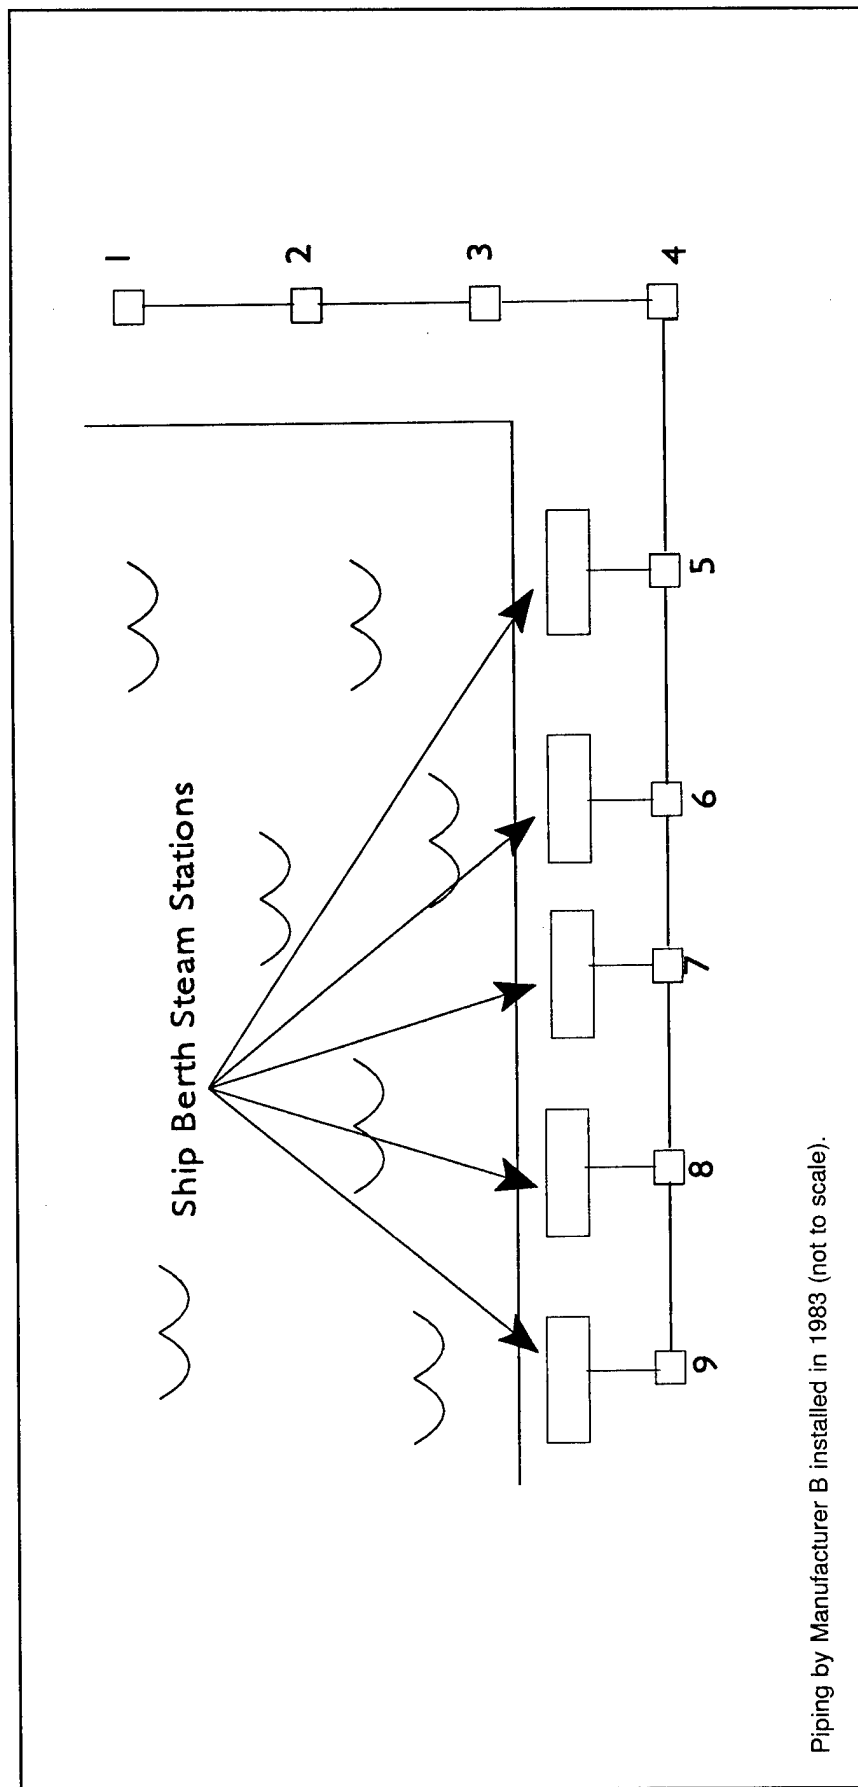
Figure J2. Schematic diagram of System 21 at Mayport Naval Station, FL.

Installed in 1983, this system consists of piping from Manufacturer B and has a steel conduit (Figure J2). A series of nine manholes serves a pier located about 800 ft north of Building 46. No condensate return piping was used. All manholes were of similar construction and design. The manholes were 6 ft × 6 ft × 10 ft deep, and most had one 6-in. manhole vent pipe. Each had solid concrete tops with 30-in.-diameter access with steel covers. No access ladders had been installed. Manhole wall penetrations were cemented and caulked. Gland seals were installed at the conduit end plates. The 8-in. steam line was contained in a 15-in. conduit. Light to very heavy steaming in all but the last manhole prevented entry for inspection. Steam escaping at a fitting was noted in Manhole 8. The last manhole at the end of the pier, Manhole 9, had no steaming but was still too hot to enter. A cathodic protection test station was found near the last manhole, but no dielectric flange connections had been installed.

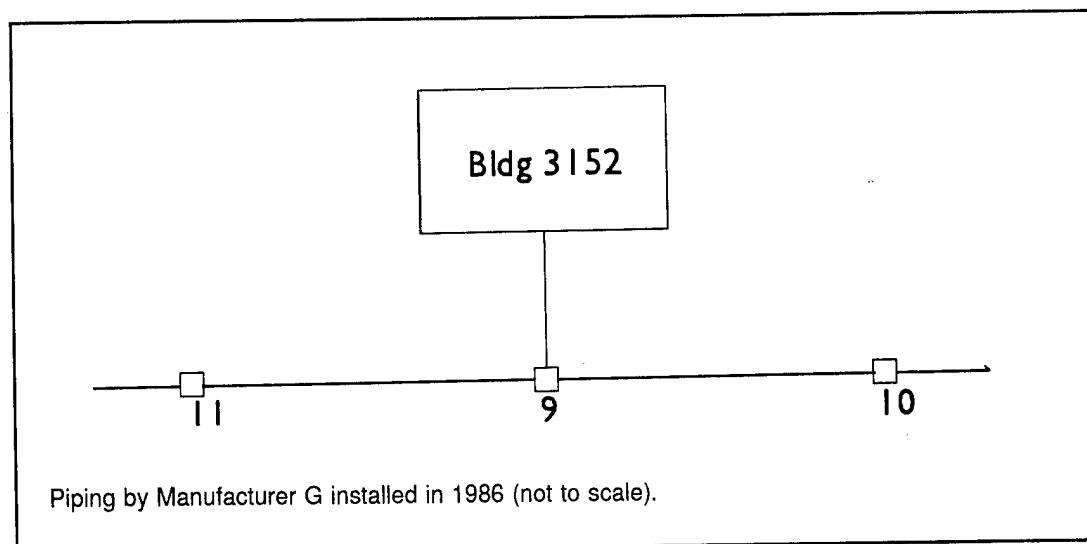
Figure O3. Schematic diagram of System 31 at Fort Lewis, WA.

Base personnel indicated that a major pipe leak was found in this system. The estimated cost for locating and repairing the leak was \$16,814 and the actual documented cost was \$14,234. However, it should be noted that the repair did not involve an "in-kind" replacement of the damaged system. Repair was accomplished by cutting out the failed section of conduit and installing a new carrier pipe covered with cellular glass insulation with a mastic coating. Cellular glass is not considered satisfactory for heat distribution system applications because of its brittleness, lack of shear strength, and its tendency to disintegrate under shock and vibration loads.

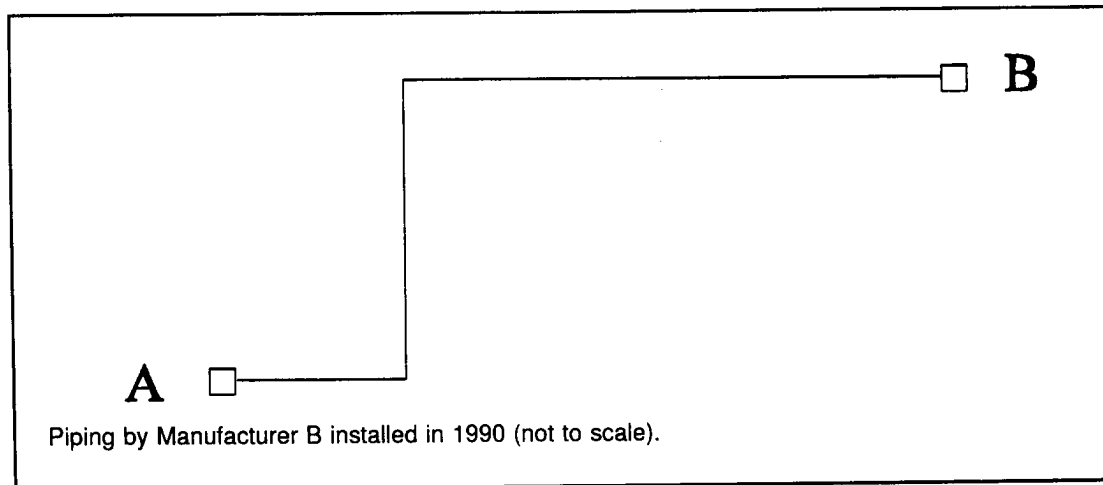
Figure P2. Schematic diagram of System 35 at San Diego Naval Station, CA.

Pressure was applied to the casing at 1:25 PM, and it slowly rose to 3 psi but would not rise further. The gland seal and gauge and compressor connections were thoroughly checked for leakage and were found to be sound. The compressor was operated for an additional 50 minutes, but no additional increase in pressure was evident. When the conduit casing was sealed by valving off the compressor, the pressure immediately dropped to zero.
